Signal

Issue 56: August 2020

The Bendix RA-1B aircraft radio receiver

Ulrich Fierz HB9AIK

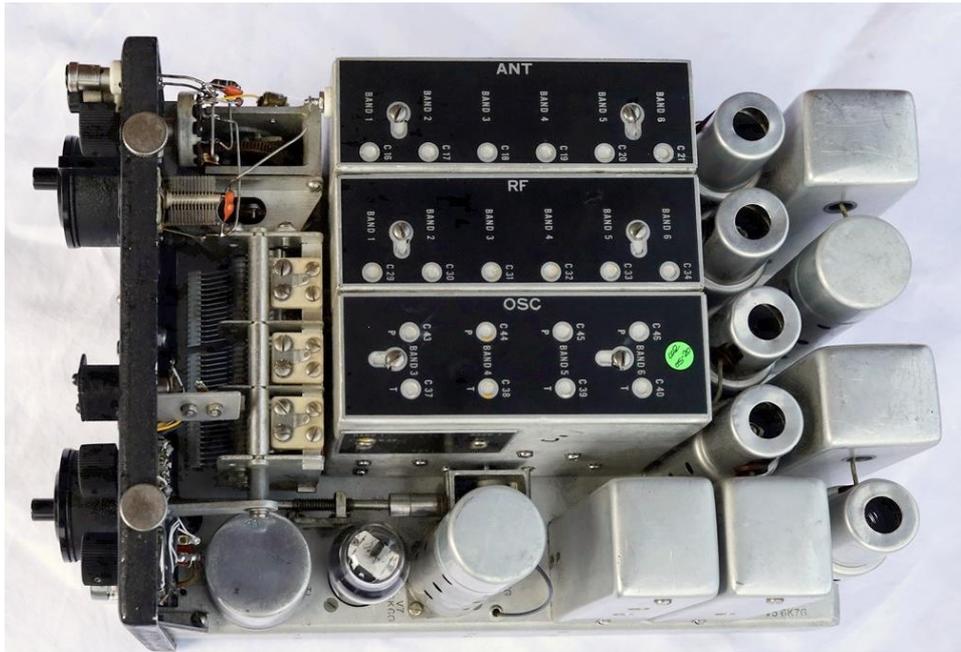
Figure 2. RA-1B: above-chassis view of the refurbished radio

The mechanical design of the radio is solid and has stood 'the test of time' well. The chassis is made of heavy-gauge welded aluminum and carries all important elements. The front panel of the same material is bolted to the chassis and carries the connectors and operator controls. The RF coils and band switches are in screened boxes, all switches, valve sockets, IF filters, etc. use ceramic insulation material. Phenolic resin is used only on the turret boards. Tuning and band switching are via worm gears driven from knobs with integrated gears for the Bowden cables on the front panel. The tuning capacitor has a back-lash compensated drive wheel on the worm. The following **Figures 2 and 3** show the chassis layout and the front panel of the refurbished radio.

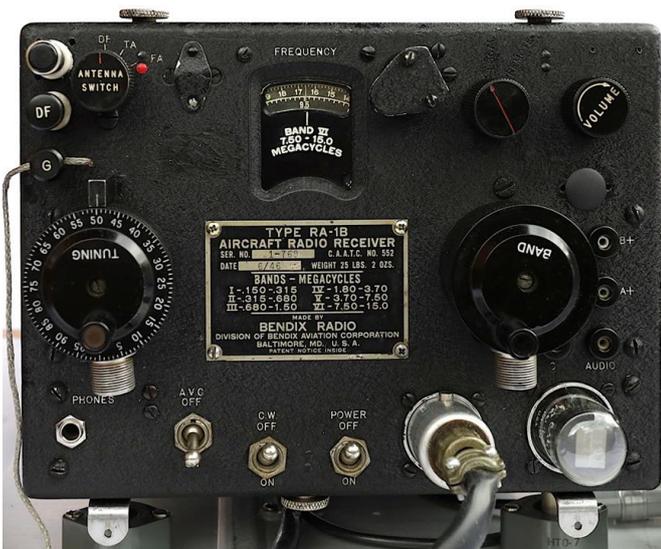
Figure 3. RA-1B front panel (refurbished radio)

The old EM87 sticking out was always somewhat vulnerable and too 'modern'. Initial thoughts leaned towards a 1629 indicator which was used in the ARC-5 command sets but, in the end, a shorter component was selected: the 6AL7GT. This is an indicator for AM/FM receivers with three rectangular sectors, used here with just one input. While not as attractive as the round magic eyes, it is compact and of the correct diameter to fit in the space of the remote connector (**Figure 3**, lower right-hand corner).

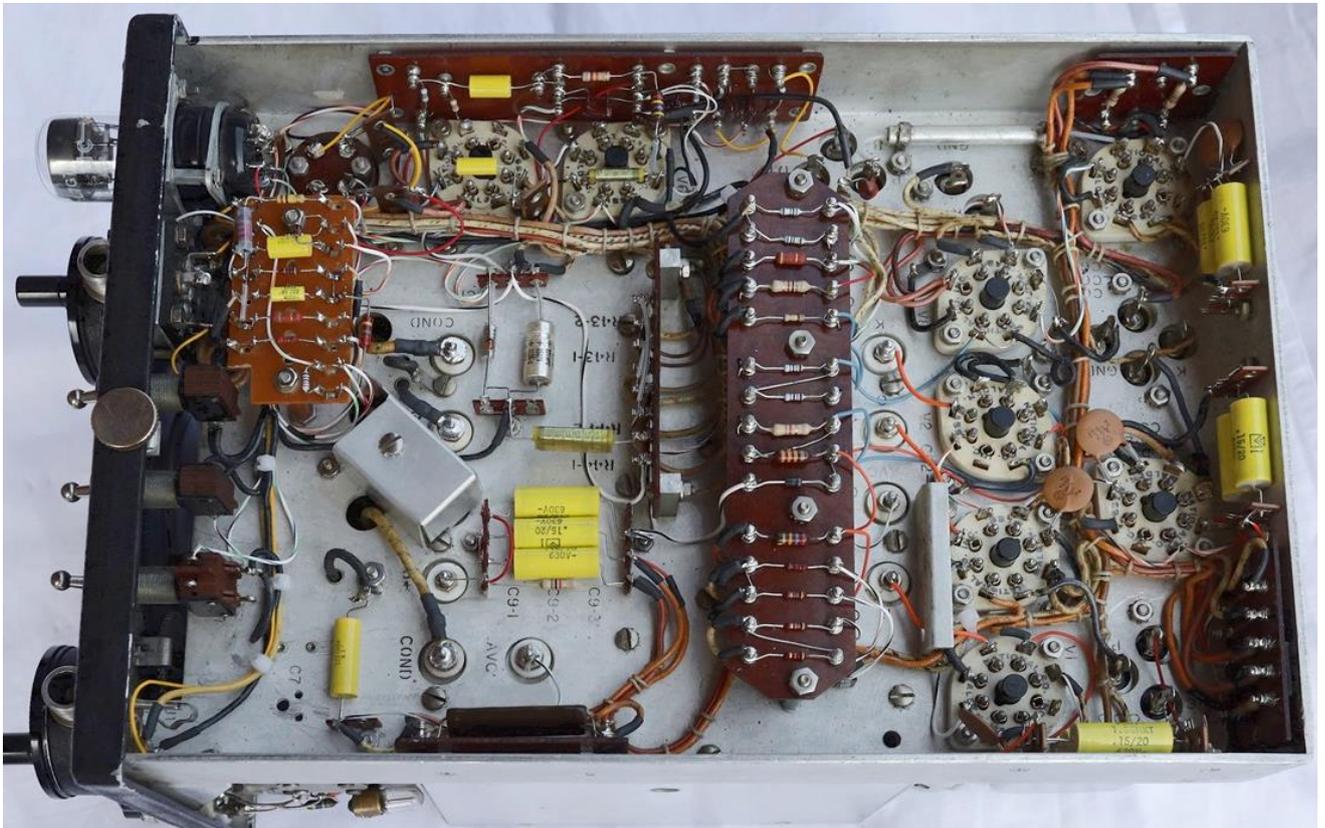
Figure 4. RA-1B: Under-chassis view of the refurbished radio

For the following description refer to **Figures 4 and 5** and the circuit diagrams in **Figures 6 and 10**.

The first step was rewiring of the heater circuit (**Table 1**). The old wire-wound resistors could be found but, due to the change in audio preamplifier valve and the addition of the tuning indicator, a new arrangement had to be found. While 24 VDC is used here, the centre is at 12 VDC and allows the optional wiring for this voltage as in the original. The equalizing resistors were put on a new tag board behind the input connector (which also carries components for the new audio and indicator circuits), but the voltage selection is still done *via* jumpers on the original tag board.

Replacing the three 100 nF bathtubs was done using 150 nF/630 V radial film capacitors and this required new terminal strips to be installed in the old mounting holes. To save space, low-voltage cathode bypass was done with 100 nF/25 V ceramic components. For the 6K6G cathode and the positive bias bypass, solid tantalum capacitors were used.

Rebuilding the cleaned turret-boards, carbon film resistors, high-value metal film and a few wire-wound power units were used. As the old values were not E12 standard, the next higher value was selected as far as possible. Only a small number of adjustments were needed later on test.

After installing the boards and the RF amplifier valve socket, the cable-form was reconnected, each end carefully terminated and a ~¼-inch shrink-sleeve applied. For the remaining wires, PTFE-insulated wire was used, if possible with the correct colour coding.

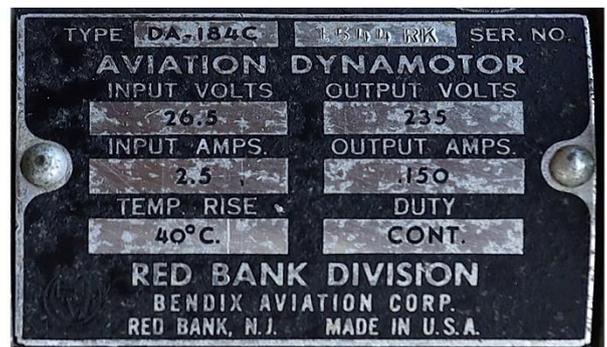
Figure 7. Dynamotor nameplate

Looking through dynamotors in stock and thinking of building a supply, the auction site was also consulted for BENDIX dynamotors. I did not find the original power supply for the radio, but a unit reasonably close in vintage, size, appearance and capabilities: DA-184C made for the ARN-14A system which provides ample B+ (at about 80 mA), was ordered and shipped from the US.

The unit includes the necessary start relay, B+ choke and filter capacitors as well as various noise-suppression components.

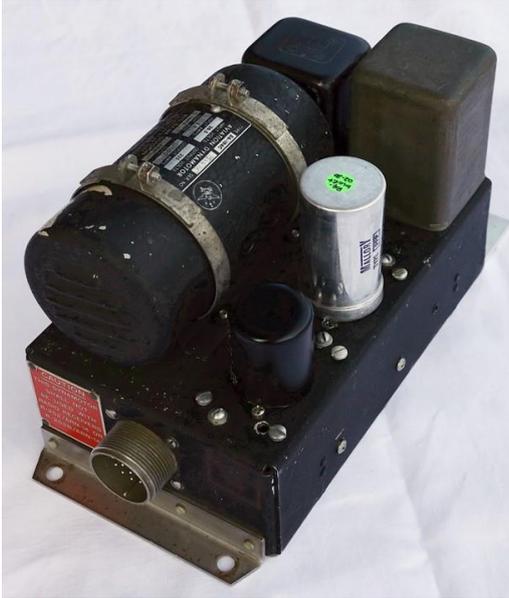
Figure 8. Dynamotor, topside (refurbished unit)

The B+ filter capacitor is now a dual unit and the resulting spare hole is occupied by the 600 Ω :8 Ω audio transformer. The outside was cleaned and the paint slightly touched up. The refurbished power supply is shown in **Figures 8 and 9**; the extended bracket is needed for the shock-mount used.

To bring it back to life, the bearings were serviced and the electrolytic and paper capacitors replaced. As there was no plug available for the round multipole socket J601, a MIL-5015 socket that fitted the existing

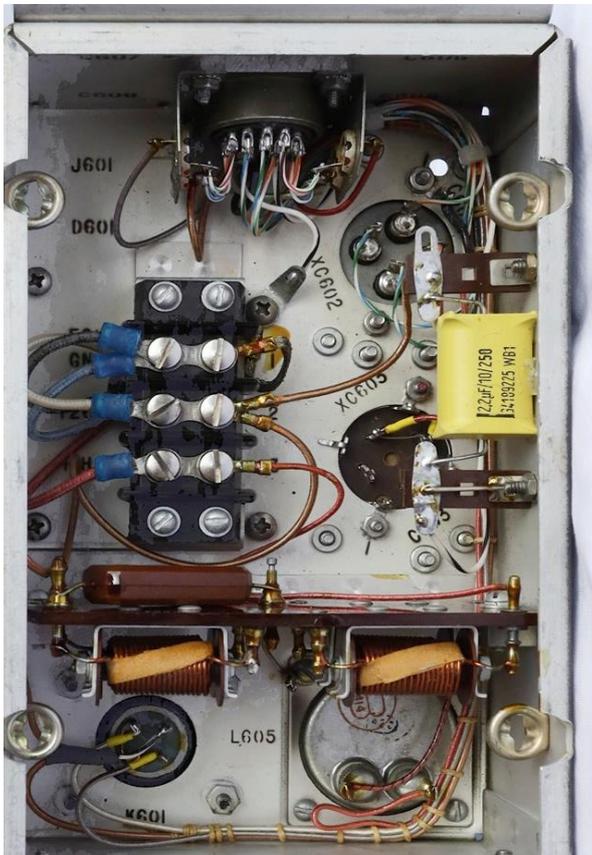
Figure 9. Dynamotor, underside (refurbished unit)

There is no circuit diagram of the dynamotor power supply, but **Figure 9** shows the components inside the chassis. In the lower section are the relay K601 and the B+ choke L605. On the tag board above are the RF filter components for the DC input and B+. In the top section C605 is the dual electrolytic and in the place of C602 is the speaker audio transformer. Note the feedthrough capacitors on the wires going to the connector.

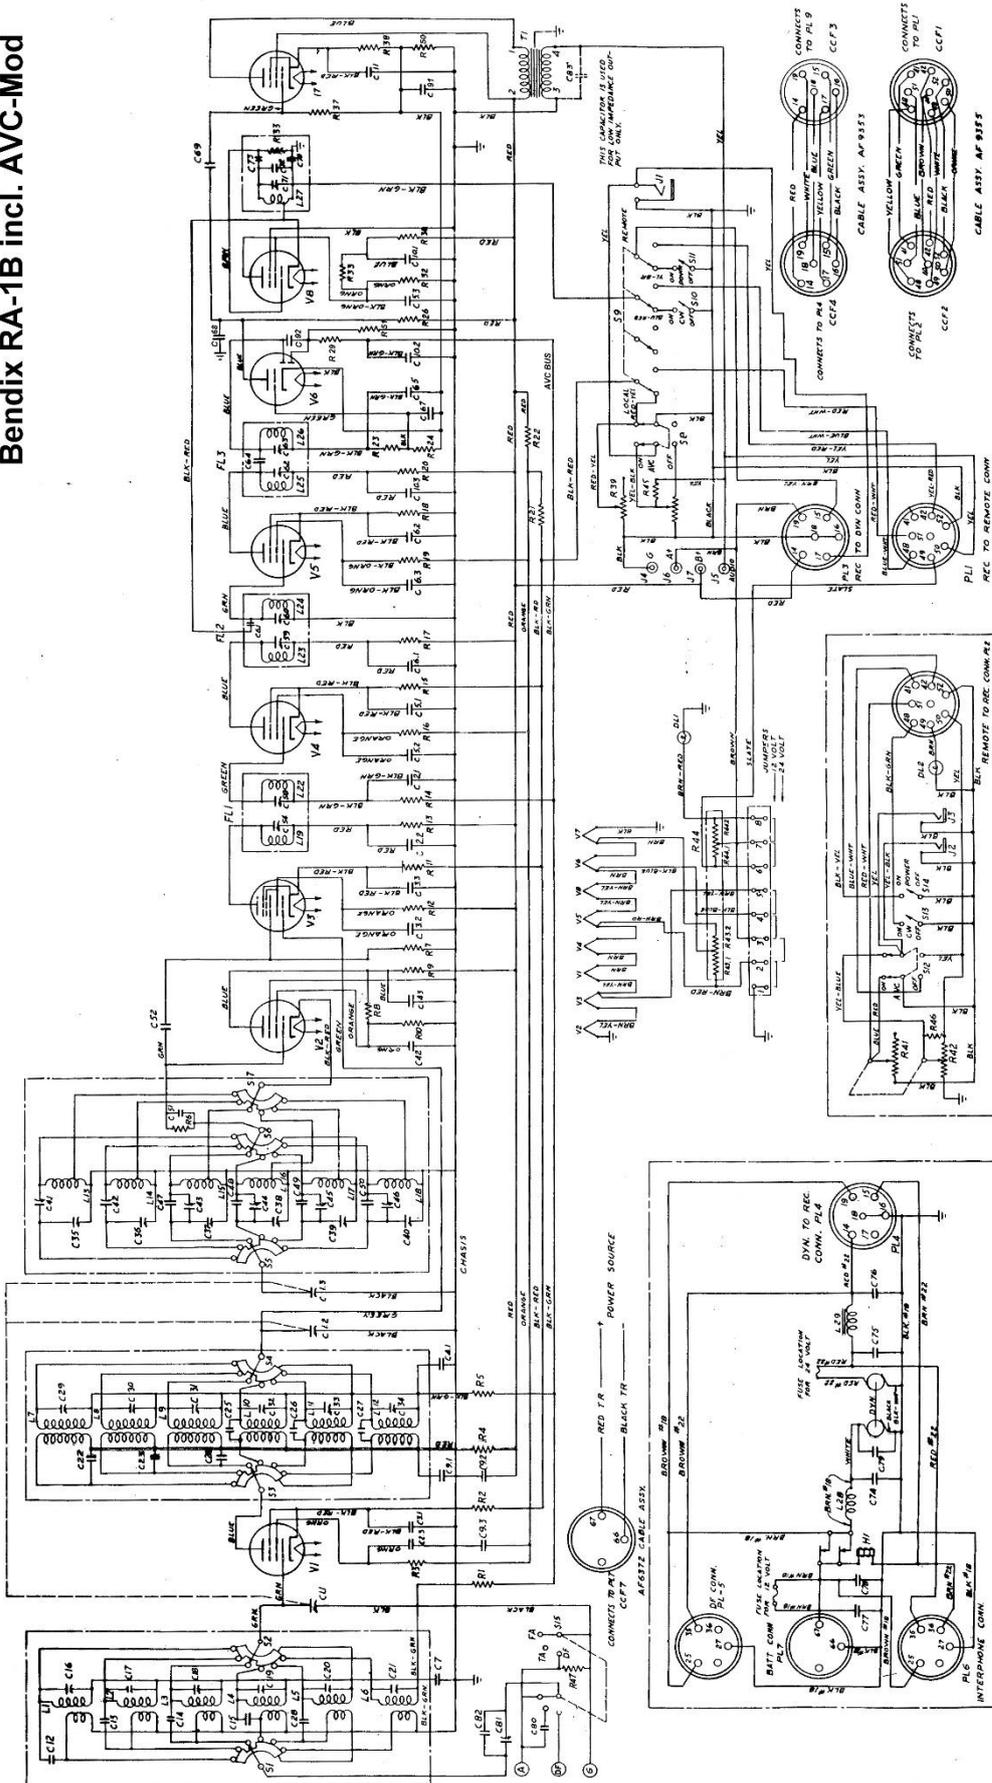
Figure 10. RA-1B original circuit diagram, but including the 1944 AGC modification but not including new component values or details as in Figure 6.

- In 1944, an important modification to the AGC design was published by Bendix and was incorporated in all later units. The author's receiver was made in this way. AGC is now rectified separately and delayed by applying a positive bias to the cathode of the 6R7G. The audio recovery path remains without bias and overall AGC performance is improved. AGC now remains always on and the AGC OFF switch just activates the RF gain potentiometer.
- The volume control is not on the input to the AF amplifier, the audio path always having constant gain. Potentiometers in the radio and in the control unit follow the output transformer and regulate the level to the headphones. AF and RF control pots are further ganged on the same axis. This arrangement,

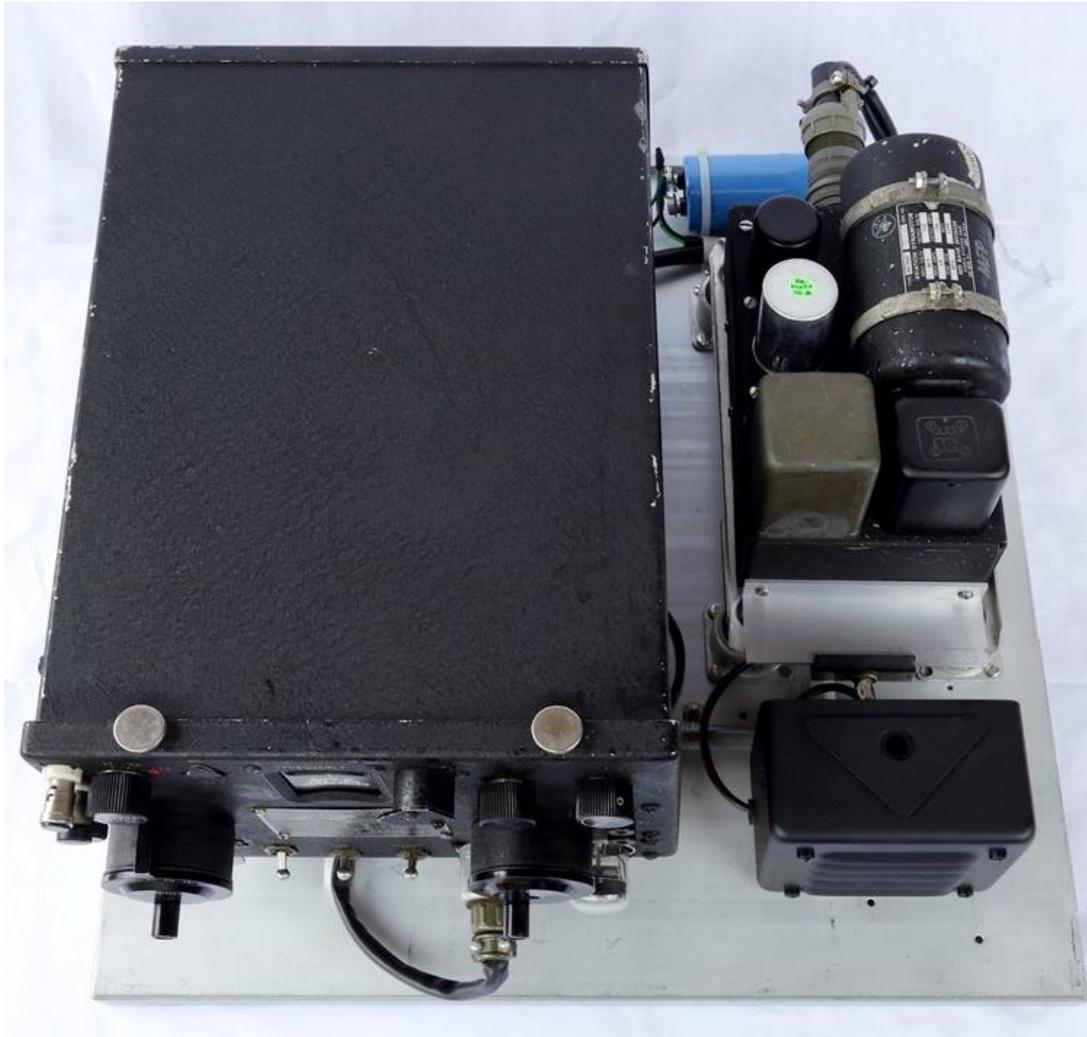
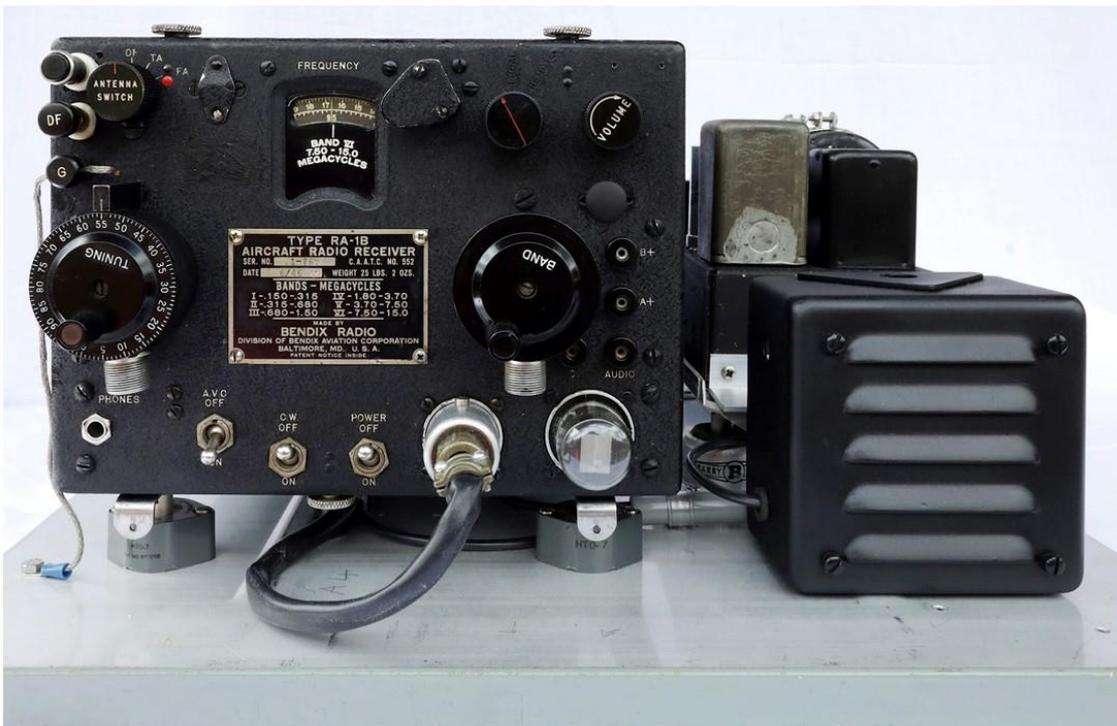
Figure 11. Layout of the RA-1B on an aluminium plinth for demonstration

In order to be able to display and demonstrate the receiver, an aluminium plinth was constructed to allow proper grounding of the components – similar to an aircraft installation (**Figure 11**).

The receiver was put on shock mounts that fit into the mounting rails of the receiver and the dynamotor was put on a suitable aircraft mount. All cables were made up using selected gauge PTFE-insulated wires for the required functions which were pulled into a silicone sleeve. As experience showed later, it would have been better also to include a shield braid to further reduce EMI.

The speaker is an old LS-166 that was repainted black and bolted to the plinth without the rear cover.

The +28 VDC power input is filtered by a high-current 2 mH choke and a large 14,000 μ F computer-grade capacitor. A series resistor consisting of three 2.7 Ω resistors in parallel reduces the input voltage to approximately 26.5 V and, at the same time, limits the inrush current into the large capacitor. **Figure 10** shows the layout of the plinth. The choke and input resistor are behind the receiver.
